## **Tephra dammed lakes in the Veidivötn area, Iceland: 2000 years of lake evolution within a volcanic system.**

Guðrún Larsen  
Institute of Earth Sciences  
University of Iceland

2023

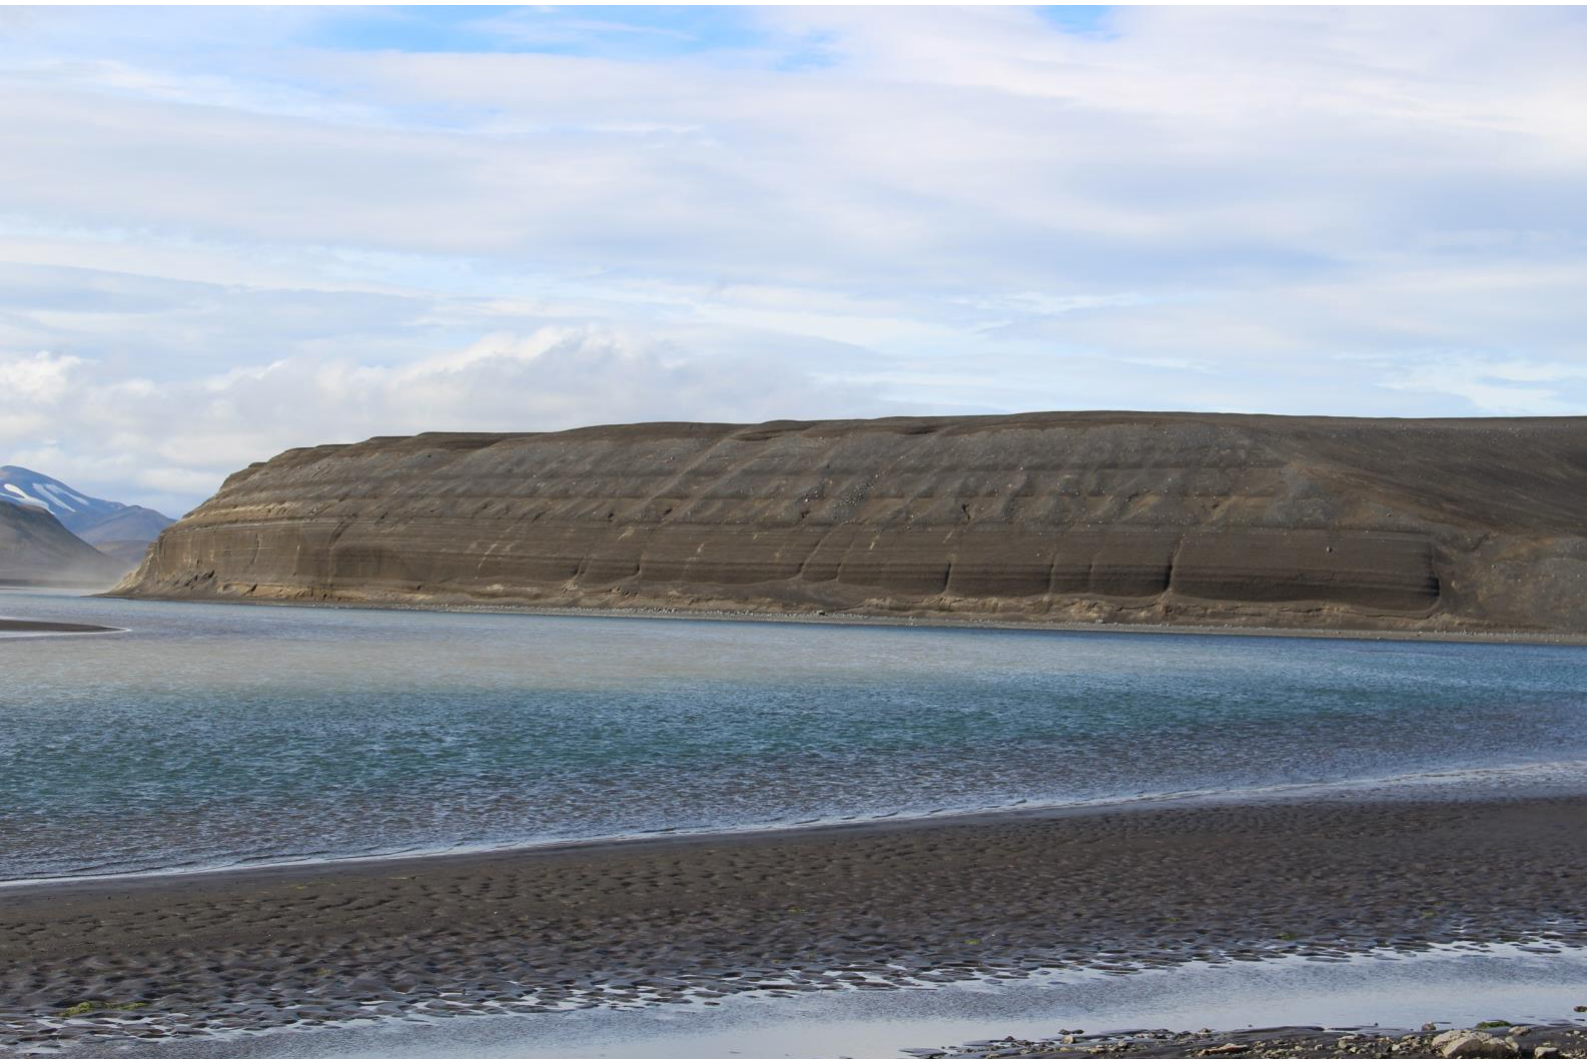
Cover photograph: Bedded, compacted tephra, 15-20 m thick, in the flank of the largest Vatnaöldur tephra ring that dammed Tungnaá river (in foreground) in 877 CE to form the temporary, unstable lake Langalón. Photo Guðrún Larsen.

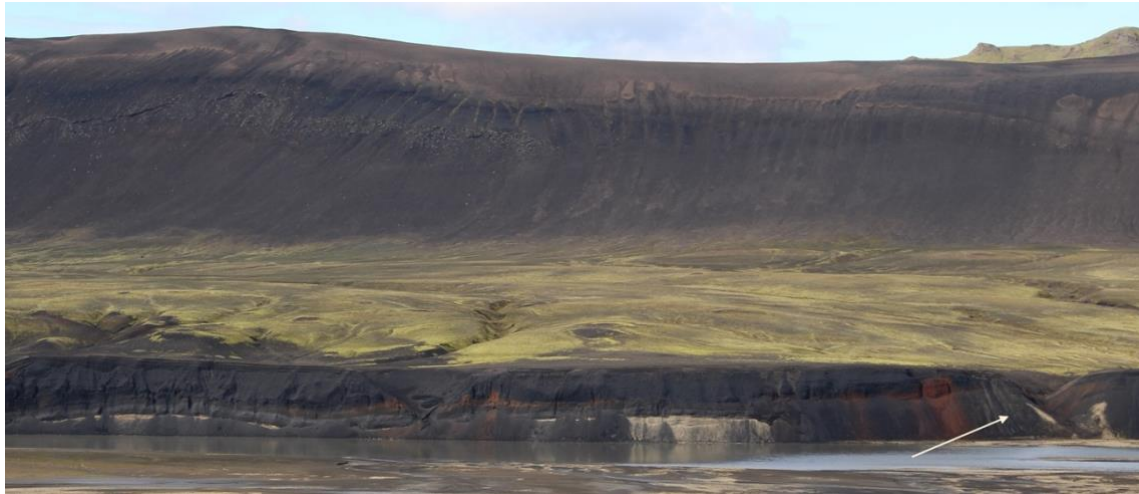
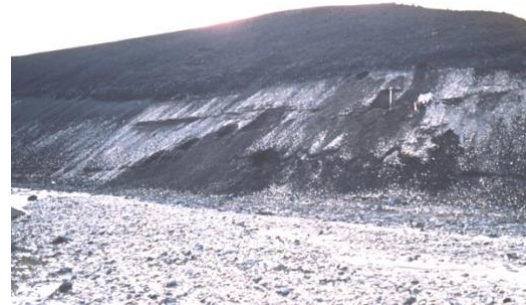
Figure 5. Top: Photograph showing an alluvial terrace of pale/beige rhyolitic gravel from the Hnausalón stage buried below a tephra slide from the SE flank of the 1477 CE Ljótípollur explosion crater, downstream from the confluence of the rivers Jökulgilskvísl and Tungnaá (photo taken 2017, see also [Appendix, Figs.1-1 and 1-6](#)). A section through the terrace (arrow), currently covered by a scree, is shown on a drawing and on the black & white photo (taken in 1982), 1 m shovel for scale. The gravel (large dots) was deposited by the Jökulgilskvísl river. Tephra from the 877 CE Vatnaöldur eruption separates the alluvium into gravel deposited during the Hnausalón stage (up to ~570 masl) and gravel from Langalón stage (up to ~572 masl). Location on Fig. 4 (black triangle 570). See also Fig. 8 (black triangle 572). NB: Conditions along this bank change as the river course shifts (meanders) and during spring floods.

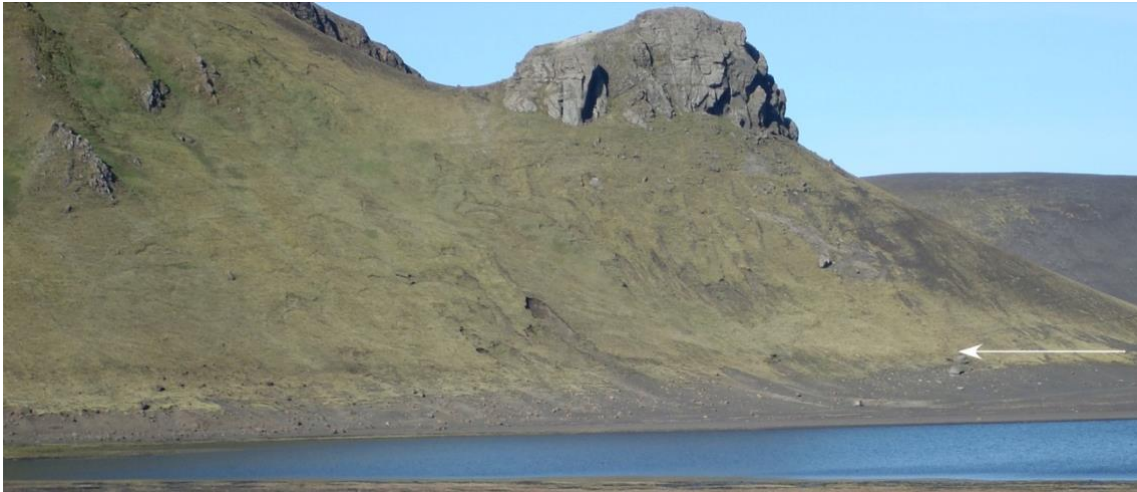
Figure 7a. The shoreline of the Langelón lake at approximately 580 m a.s.l. on the lower southeast slope of Tjörvafell hill. The big rock on the hillside is at 670 m a.s.l. Here only one shoreline is discernible as a break in slope and changed or no vegetation. In some places “washed” (fines depleted), uncompacted Vatnaöldur tephra is found below/at the break. See also [Appendix, Fig. 3-1](#).

Shorelines of a lake have been found in the Vatnaöldur tephra in several places (S-S' on Fig. 6, Fig. 7a). Comparison to maps with 5 m contours indicates elevations close to 580 m a.s.l. for shorelines in areas that were not submerged by younger temporary lakes of the Kýlingalón stage (section 5.7), best developed on the SE slope of Tjörvafell hill and on both sides of the isthmus between the hills (Fig. 7b). In the SW end of the basin and in the river basin of Tungnaá the highest shoreline lies at roughly 580 m a.s.l. (582.5 m a.s.l. by reference to Sudurlína pylon), but interference with younger Kýlingalón shorelines makes this maximum uncertain.

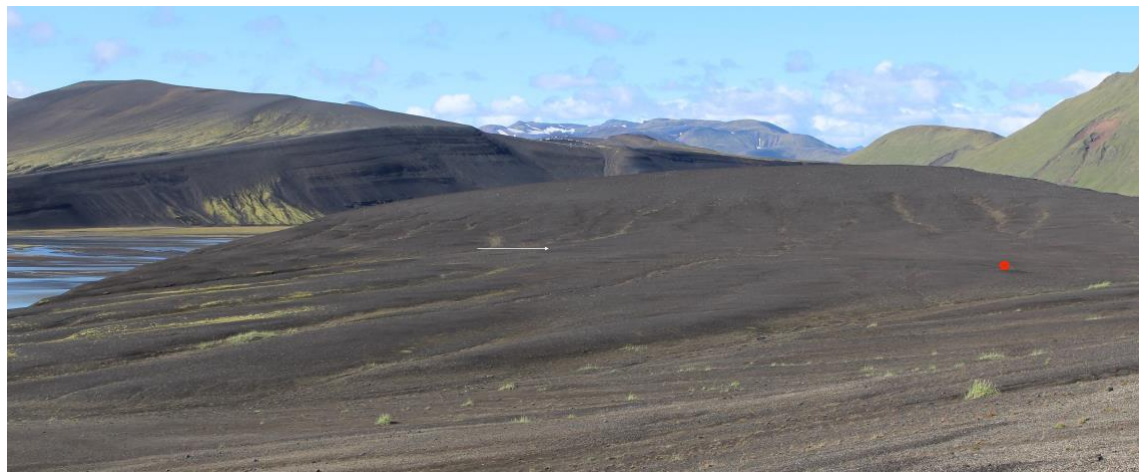
Figure 10 b. The breached tephra dam (main dam) between the rims of Ljótípollur crater (top, left) and adjacent Svartíkrókur crater (closer), Tungnaá flows to the right through the breach. Highest water level of the Kýlingalón lake on the crater flank is indicated by white line. Red dot is 1.7 m across. Note the change in slope and appearance from gentle sloping smooth surface at the top of the crater rim to water carved/washed surface below the level of the lake. View towards SW. Photo Adalsteinn Eiríksson.

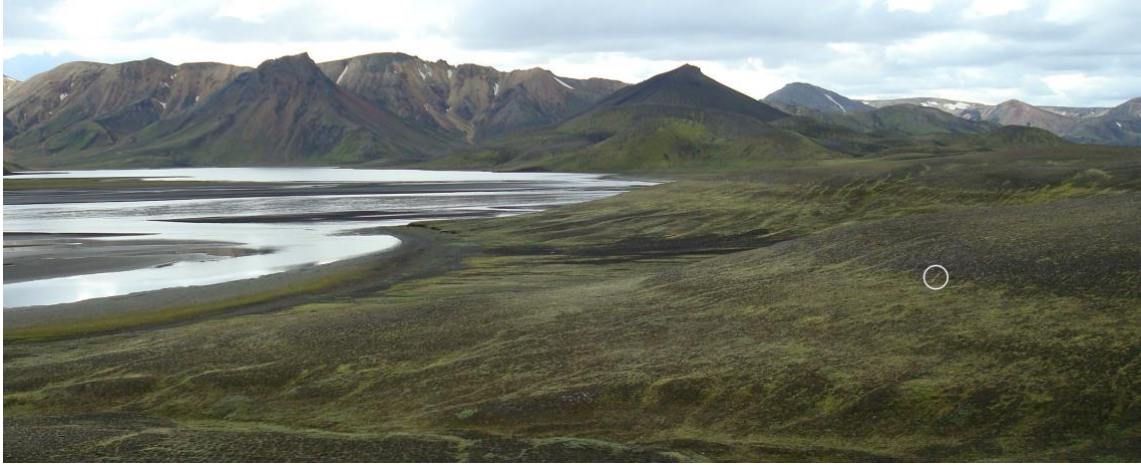
Figure 10 d. Three (to four) shorelines near Austurkrókur, note the 1 m long spade (in white circle, uppermost line). Here the middle line is most prominent. View towards S across the Tungnaá river to Barmur, Torfajökull area. For location of the photos in Fig. 10 see [Fig. 5-5 in Appendix 5](#).

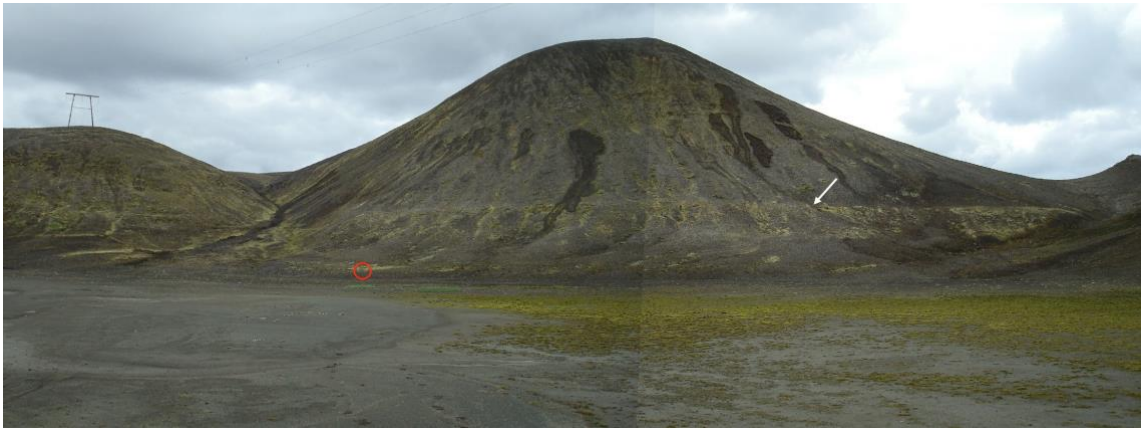
Figure 10 e. Shorelines of Kýlingalón - and Langalón - at Austurbjallar between the lakes Austurbjallavatn and Litla Austurbjallavatn (to the left beyond the dry flats). The uppermost shoreline is cut into tephra from the 877 CE Vatnaöldur eruption and is overlain by “water-transported” tephra from the 1477 CE Veidivötn eruption. Arrow shows where elevation (582.5 m a.s.l.) was determined by reference to the base code of Sudurlína pylon and the section measured (see main text). Red circle is 1.8 m in diameter. View towards N.

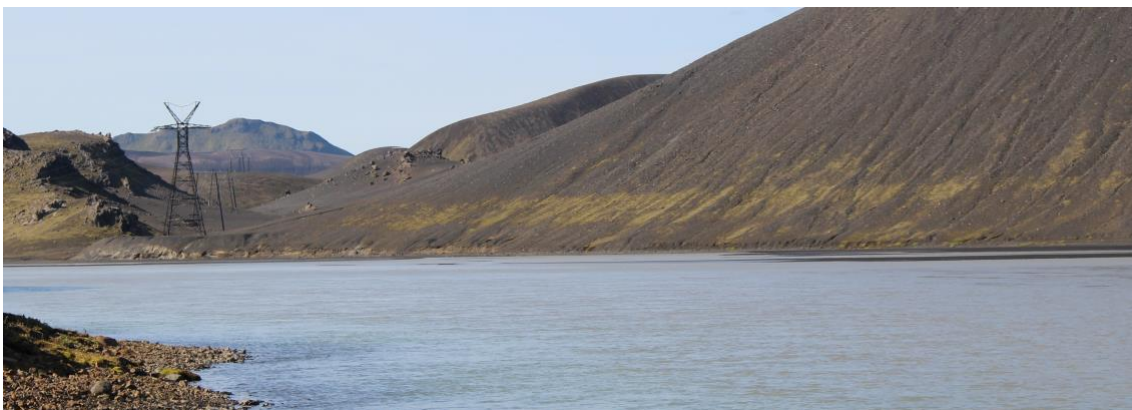
Figure 10 f. Shoreline, defined by yellow-green vegetation, along the Tungnaá river (north bank) at Hnaus mountain, 5 km upstream from Ljótípollur crater. Pylon for scale. View towards NW across the Tungnaá river from Stóri Kýlingur hill.

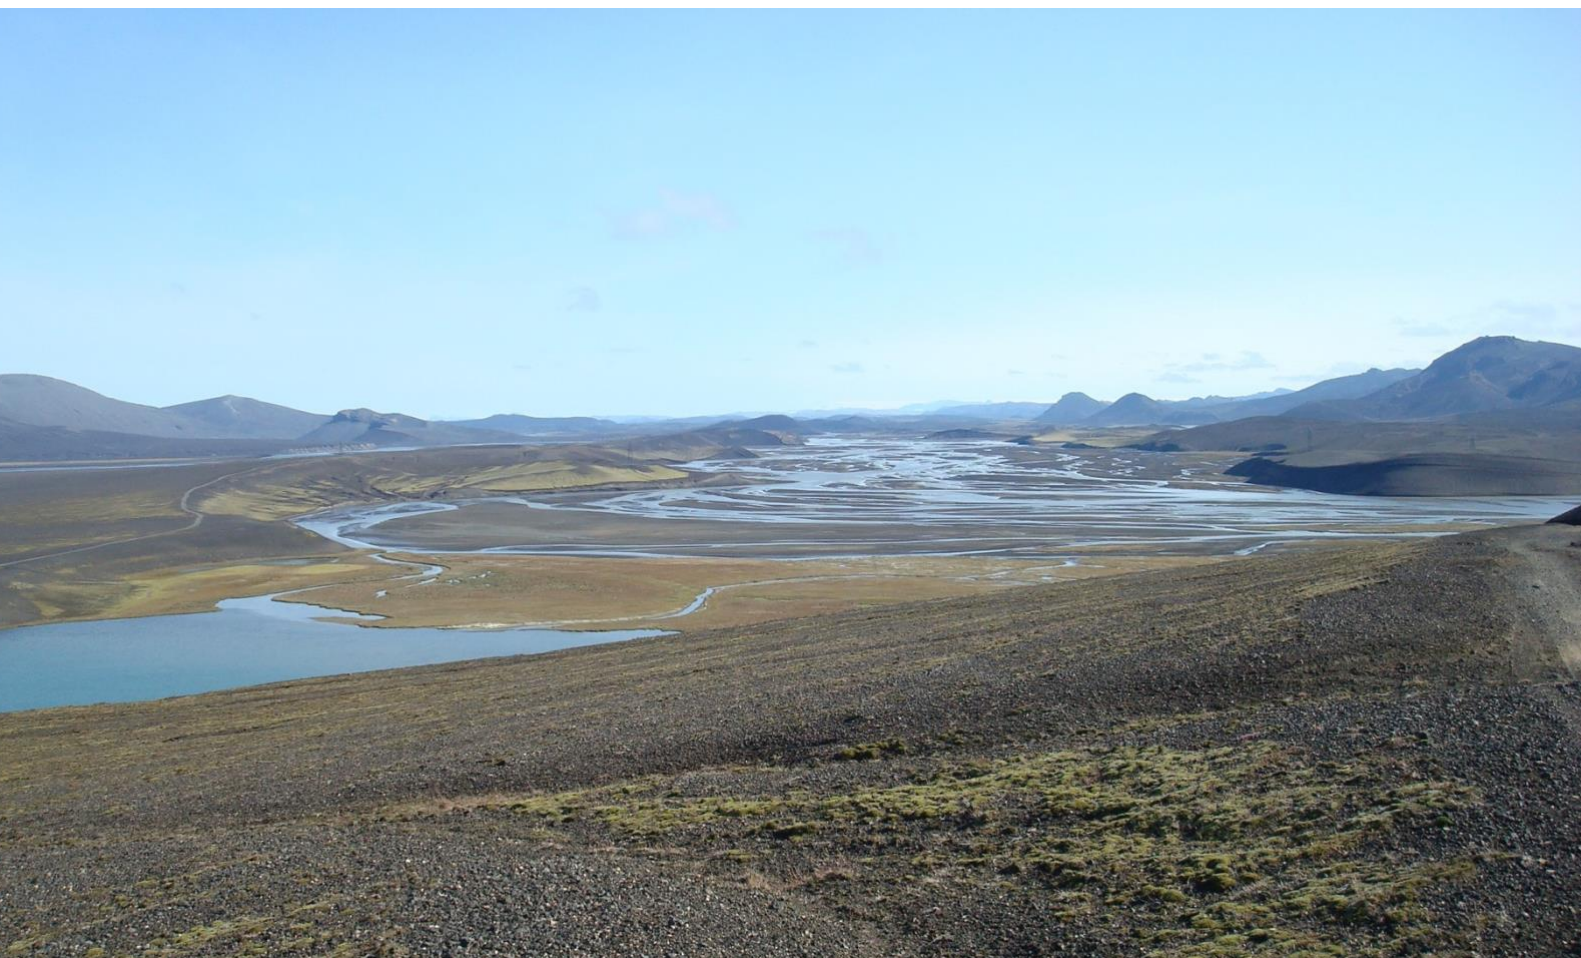
Looking NE along the Tungnaá river flowing within the 1477 CE Svartikrókur tephra rings and the former Snjóöldulón, now filled by alluvium of Jökulgilskvísl and Tungnaá rivers.

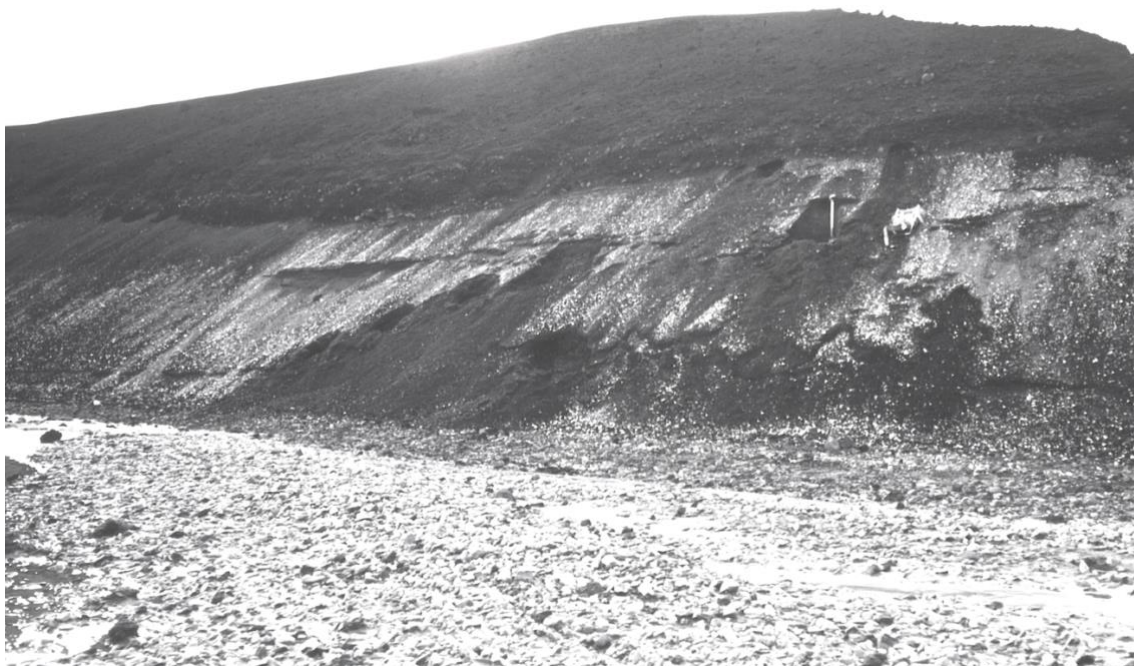
Figure 1-6. A section through the terrace (now covered by a scree) logged in 1982, the black & white photo taken at that time. 1 m shovel is standing in the cleaned section through the Vatnaöldur tephra.

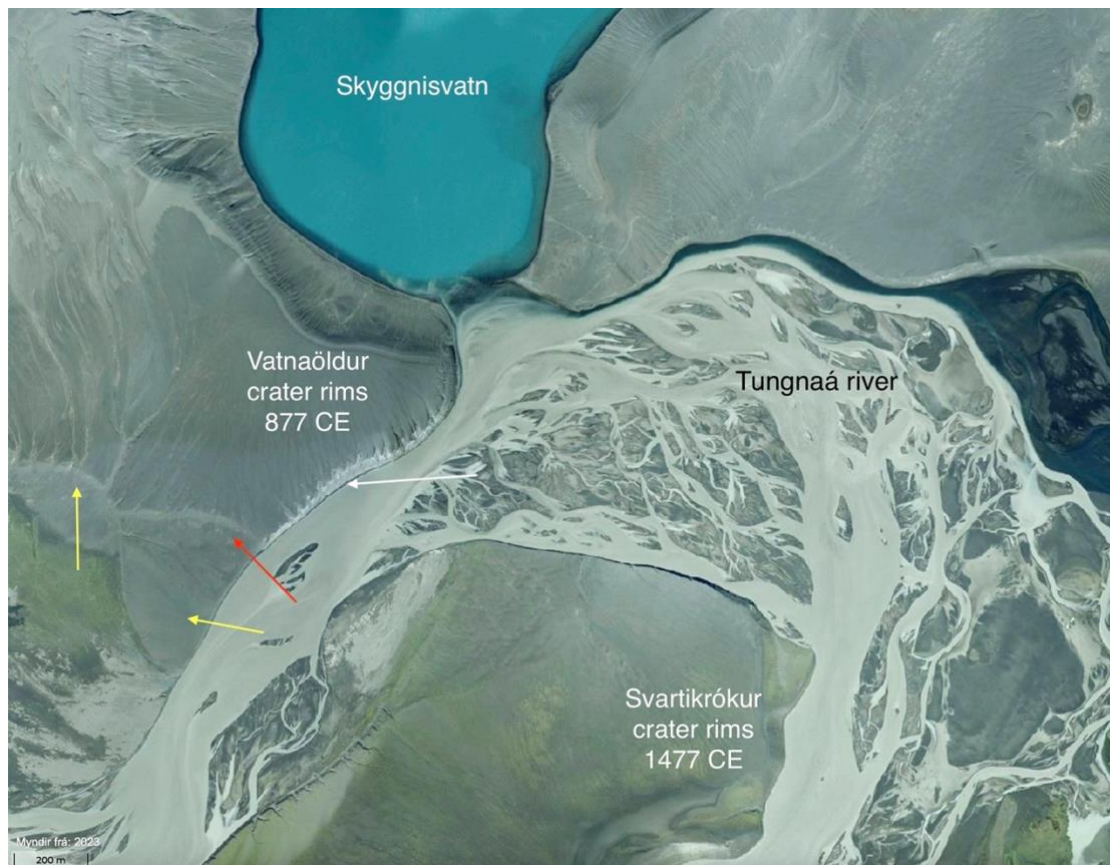
Figure 2-1. Aerial photograph from MAP.IS/Loftmyndir ehf, showing the south rim and flank of the largest Vatnaöldur crater, lake Skyggnisvatn and the Tungnaá river. The 877 CE Vatnaöldur tephra is light grey and is partly mantled by dark grey air fall tephra from the 1477 CE Veidivötn eruption, originating from the Svartikrókur crater row (remnants of crater rims in lower part of figure).

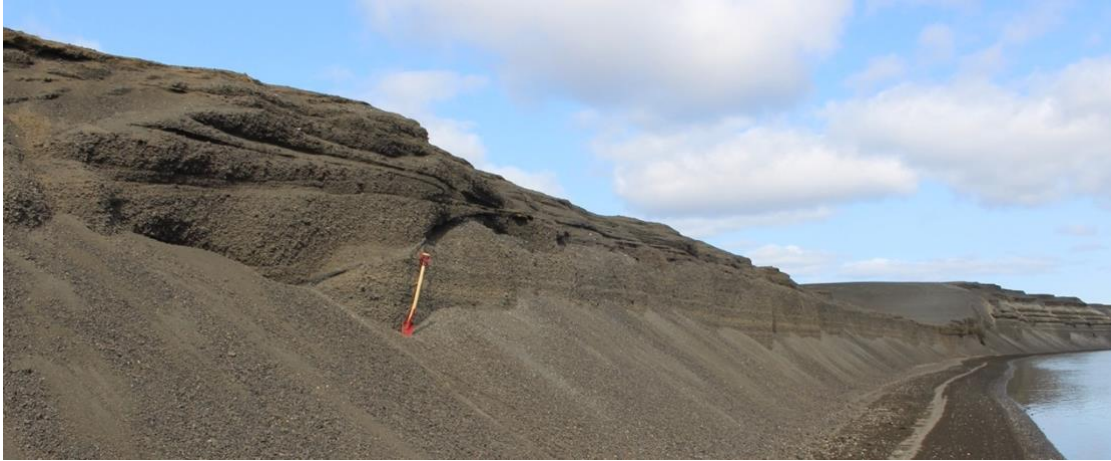
Figure 2-2. Thick deposit of 1477 CE Veidivötn tephra in the flood channel/scarp on Fig. 2-1. Photo taken near the lower yellow arrow on Fig. 2-1. To the right of the shovel (1 m) is massive primary airfall of bedded lapilli, bombs and ash with lithics of rhyolite gravel and basalt fragments. To the left of the shovel the Veidivötn air fall tephra has been eroded and on top of it lies irregularly bedded, water transported lapilli and ash filling shallow channels, presumably deposited during the emptying of Snjóöldulón-Kýlingalón lakes. To the far right the Veidivötn airfall tephra drapes over the scarp in the Vatnaöldur crater flank (red arrow on Fig. 2-1, close-up on Fig. 2-3).

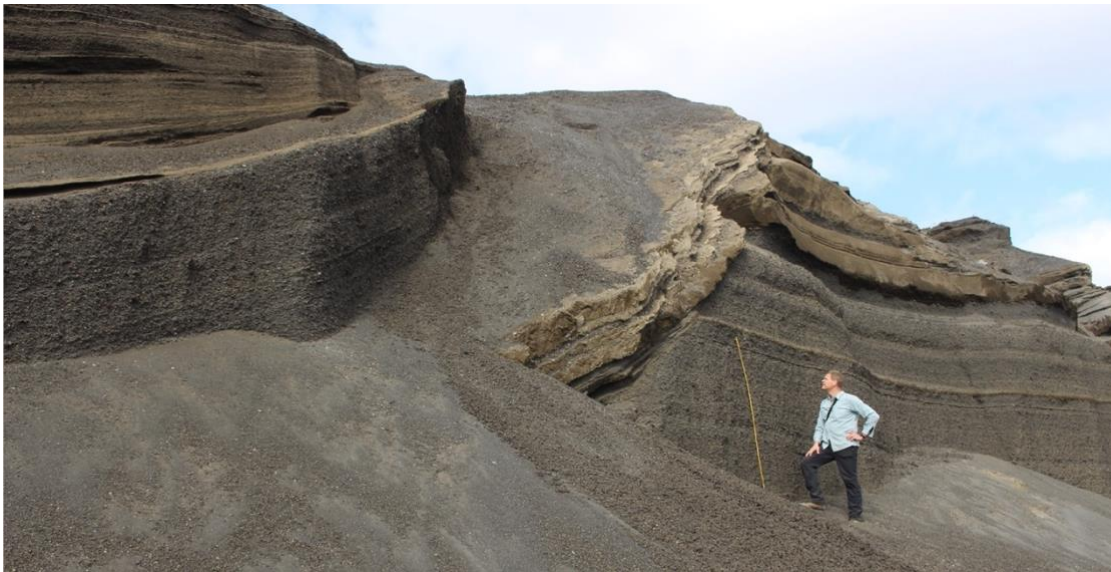
Figure 2-3. Close-up of the flood channel/scarp eroded into the Vatnaöldur crater flank. Photo taken to the right of the red arrow on Fig. 2-1. The truncated, bedded Vatnaöldur tephra (2 m scale) at the scarp is first overlain by wind and water redeposited Vatnaöldur tephra. Massive deposit of bedded Veidivötn airfall tephra (bombs, lapilli, ash and rhyolitic lithics) overlies the Vatnaöldur tephra, draping over the scarp, and is in turn overlain by redeposited, thinly bedded Veidivötn tephra. Close-up of the Vatnaöldur tephra is on Fig. 2-4.

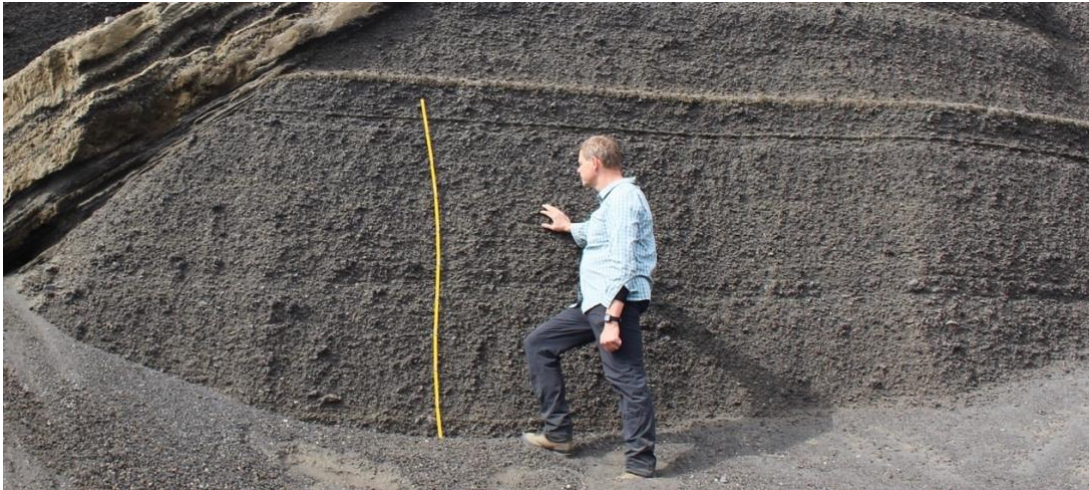
Figure 2-4. Close-up of the lowermost exposed tephra in the Vatnaöldur crater flank. Massive, compact lapilli and bomb deposit with sparse basaltic lithics (completely without rhyolitic lithics), are interpreted as airfall. Thin ash-rich layers could be surge deposits. The tephra dam of Langalón lake consisted of this material.

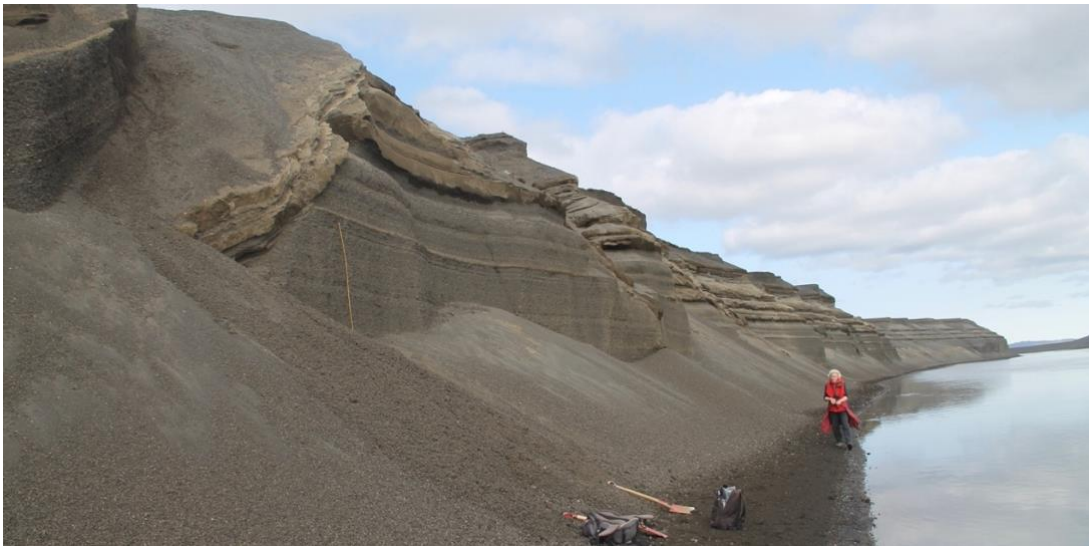
Figure 2-5. A view towards NE along the erosional scar cut into the Vatnaöldur crater flank during the emptying of Snjóöldulón-Kýlingalón lakes, now the river-bank of Tungnaá, white arrow on Fig. 2-1. The thick, massive, lowest beds continue as far as seen (forming near-vertical wall) overlain by thinner airfall and surge beds. Person for scale is 1.7 m. Photo Magnús T. Guðmundsson.

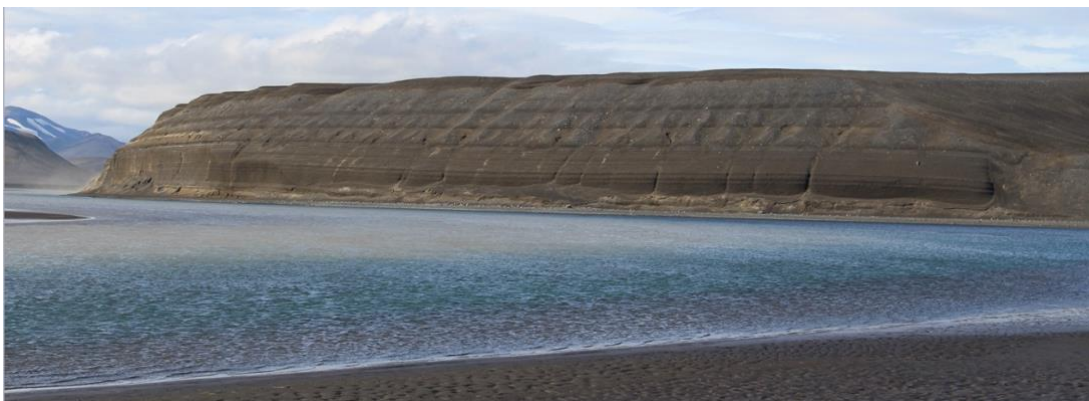
Figure 2-6. Bedded, 15-20 m compacted tephra in the Vatnaöldur crater flank seen from NE across Tungnaá and Ósinn, the outlet of Lake Skyggnisvatn.

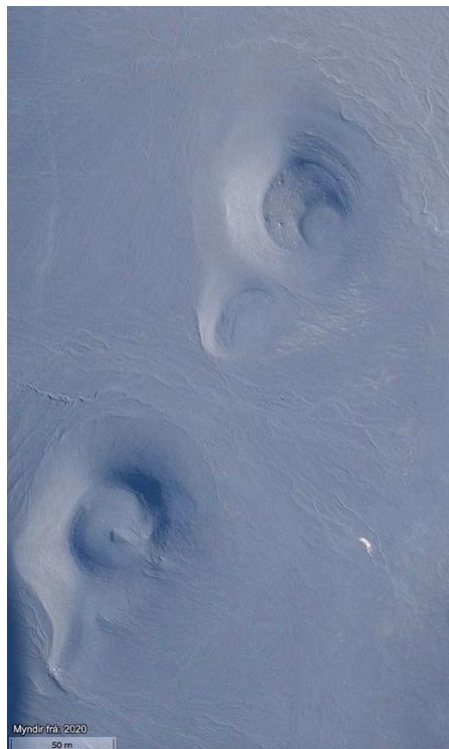
Figure 3-2. Aerial photograph from MAP.IS Loftmyndir ehf. Four small cones of basaltic tephra belonging to the 877 CE Vatnaöldur eruption lie on the lower slope of Hnausar hill. They constitute the southern end of the tephra dam holding up the Langalón lake. The two northernmost cones are partly washed away. The third cone, lying between 575 and 580 m a.s.l. mostly retains its shape although its flanks are eroded. Of the fourth and southernmost cone only small part of a rim remains. North is up.

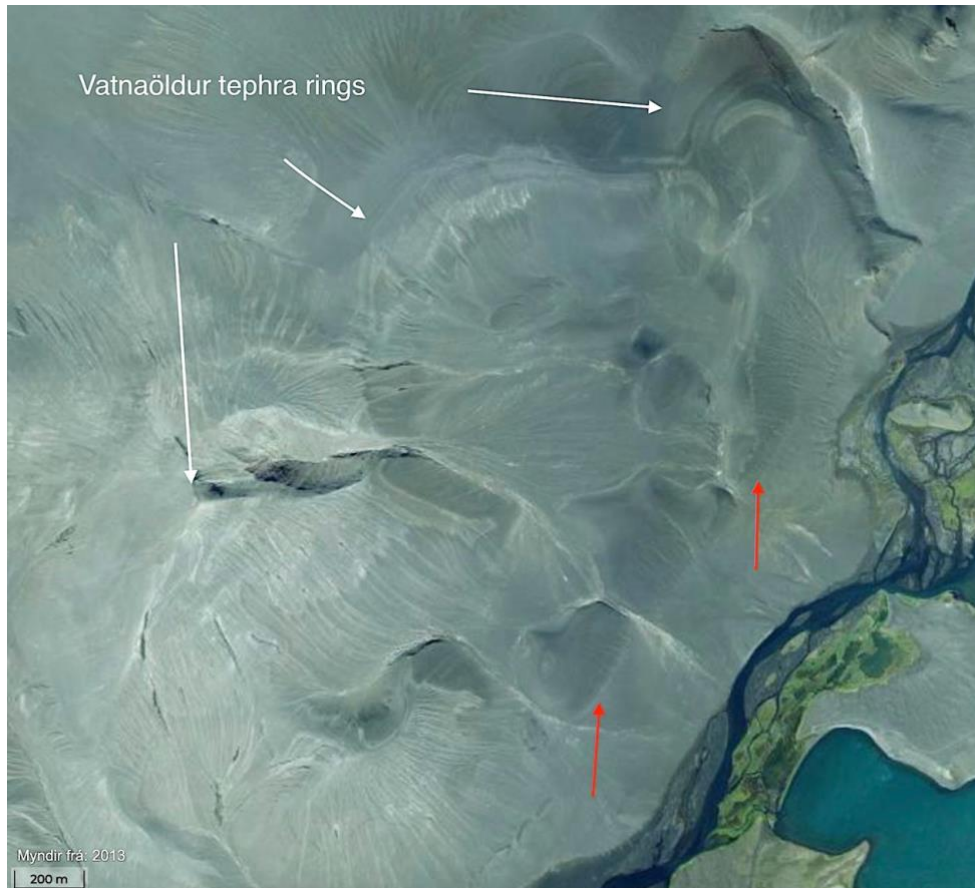
Figure 3-3. Aerial photograph from MAP.IS/Loftmyndir ehf. Three large tephra rings in the 877 CE Vatnaöldur fremri crater row (white arrows point to NW rims) lie at the margin of the Veidivötn basin with the somewhat deformed SE rims built into the basin. The two larger tephra rings are eroded and tectonic fault cuts one of the rims. Darker coat of tephra from the 1477 CE Veidivötn eruption overlies the flanks. A step is cut into the SE flanks (red arrows) slightly above 580 m a.s.l. Below the step is a cover of slope-wash and remobilised tephra (lighter in colour). The step may mark the highest water level of Langalón lake. Tectonic fault cannot be excluded but no continuation of such fault has been found.

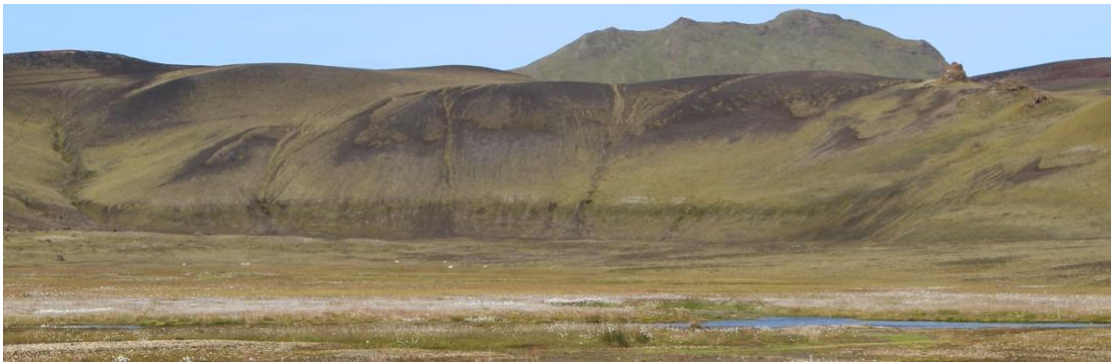
Figure 5-1. Shorelines on the S slope of 1477 CE Ljótípollur explosion crater, upstream of the tephra slide that formed a second dam across Tungnaá river. At least two lines are discernable. The notch of the upper line lies at or above the 580 m a.s.l. contour (can also be observed on MAP.IS with 20 contour lines). They record at least two steps in the emptying of the Kýlingalón lake.

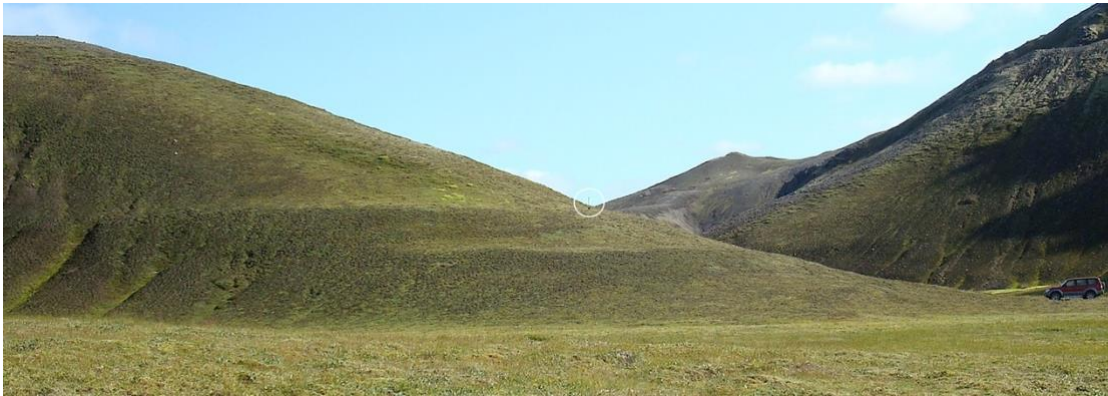
Figure 5-2. Three steps or shorelines are preserved on a slope at Stóri Kýlingur (left) in the narrows between the hill and the Kirkjufell mountain (right). The lowermost step is indistinct (level slightly above the car at far right). Shovel ~1m standing on upper most step (white circle). Only one shoreline is preserved on the scree-covered slopes of Kirkjufell. A shallow pit was dug into the middle shoreline in early summer 1981. The upper part of the section was soil with a few dark tephra layers. At about 20-30 cm depth a 6-8 cm thick, irregularly bedded, basaltic tephra was found. It had the grain characteristics of the 1477 CE Veidivötn tephra including small rhyolitic lithics and was interpreted as reworked remnants of that tephra. A layer of soil separated this tephra from a washed, irregularly bedded basaltic tephra. Some of the beds were crystal-rich with the grain characteristics of the 877 CE Vatnaöldur tephra. Frozen ground prevented further digging. The area lies within The Fjallabak Natural Reserve and has not been re-surveyed.

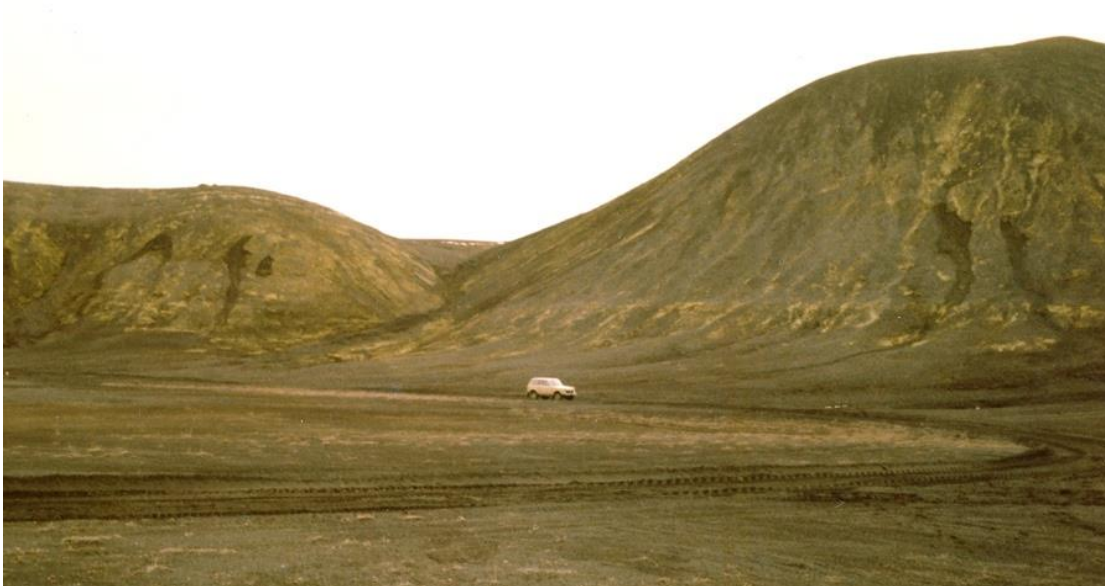
Figure 5-3. Shoreline at ~580 m a.s.l at Litla Austurbjallavatn, marked by better preservation of vegetation. This shoreline is, at least in some places, cut into “washed” Vatnaöldur tephra indicating that Langalón lake formed the shoreline. It is, however, overlain by water carried Veidivötn lapilli. The area lies within The Fjallabak Natural Reserve. The shoreline was dug out and the bench surveyed to 582.5 m a.s.l. during the building of the Sudurlína transmission line in 1982.

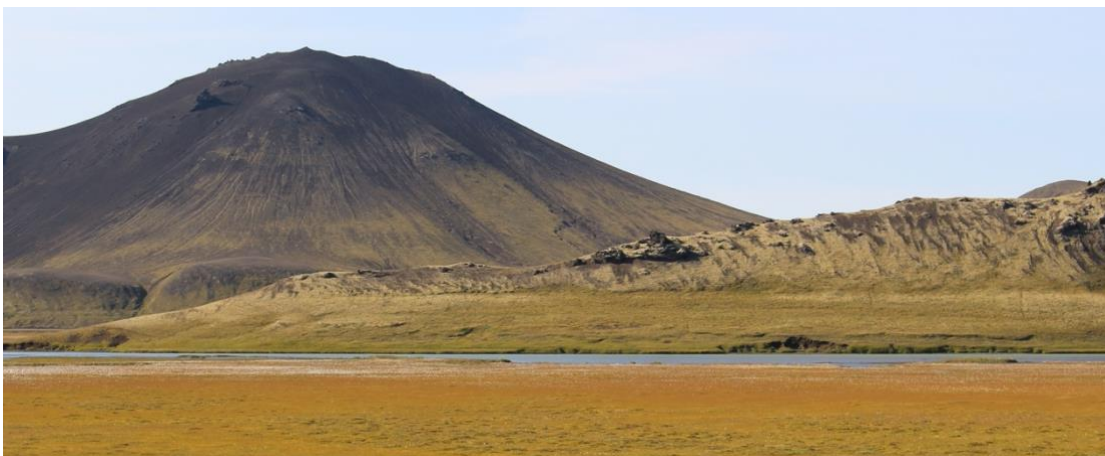
Figure 5-4. Shorelines at Litli Kýlingur, the uppermost line most distinct. Kjartansson (1959) described shorelines in the Kýlingar area where the (uppermost) shoreline was found to be 12 m above the river in summer 1959. The river is close to 570 m a.s.l. at Litli Kýlingur. The shorelines have not been inspected as they are on the other side of Tungnaá river. The area lies within The Fjallabak Natural Reserve.

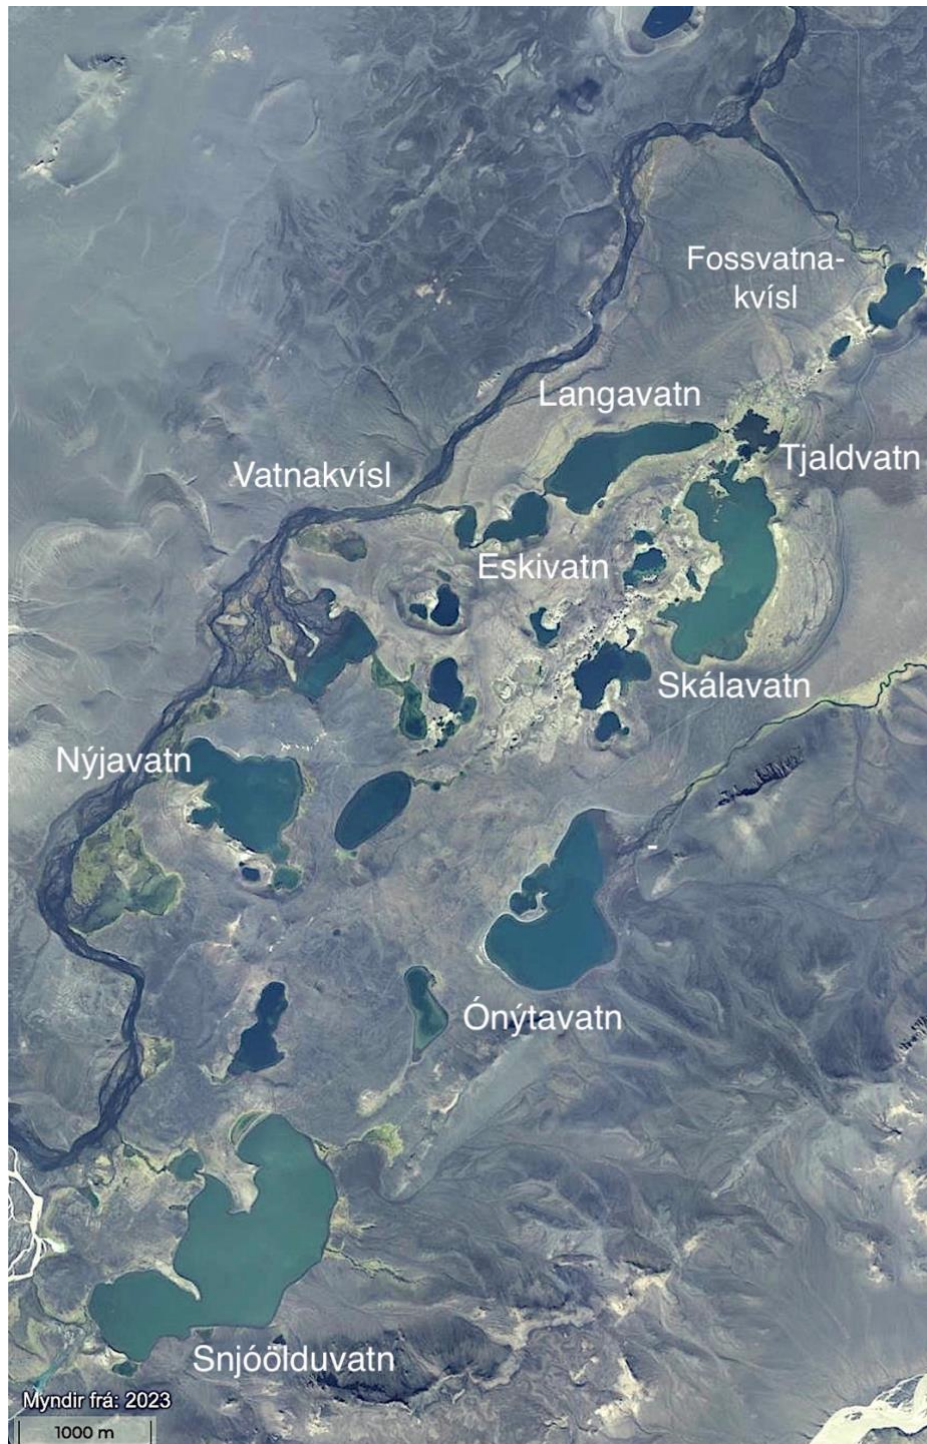
Figure 6-1. Aerial photograph from MAP.IS Loftmyndir ehf. Overview of the central part of the Veidivötn basin with names of relevant lakes and rivers. Scale in lower left corner. (Colour of aerial photo slightly changed).

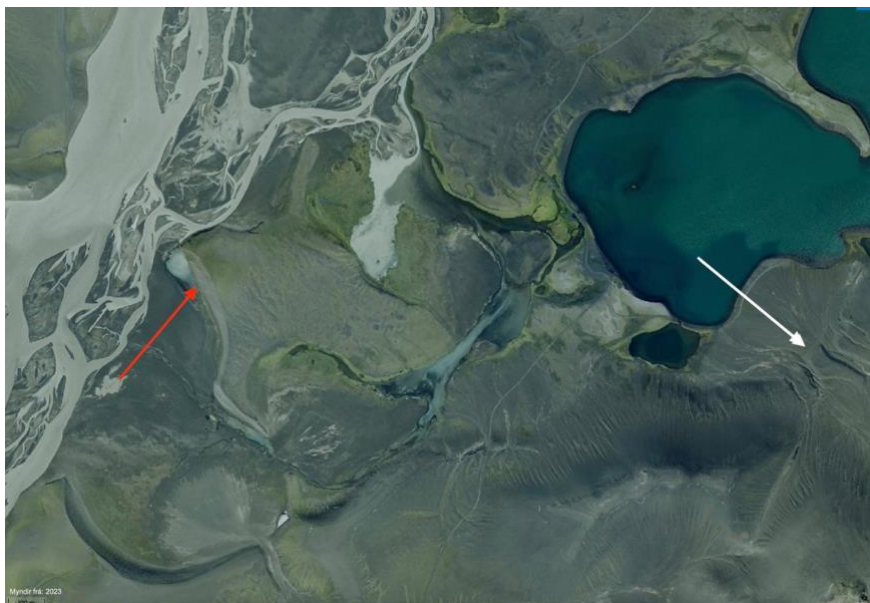
Figure 6-2. Aerial photograph from MAP.IS Loftmyndir ehf. SW part of the present Snjóölduvatn and its original outlet. White arrow points to a scarp formed during the highest water level. Two channels were formed during the emptying with remnants of a crater flank (red arrow) in between. Aerial photo from 2013.

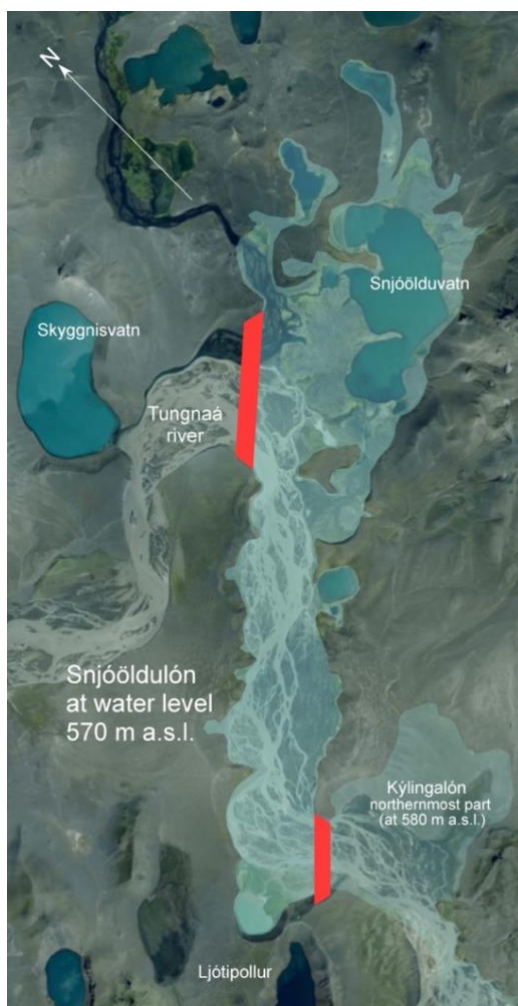
Figure 6-3. Aerial photograph from MAP.IS Loftmyndir ehf. Transparent blue overlay indicates the potential temporary extent of Snjóöldulón inferred from sporadic shorelines and scarps and the present topography and elevation.

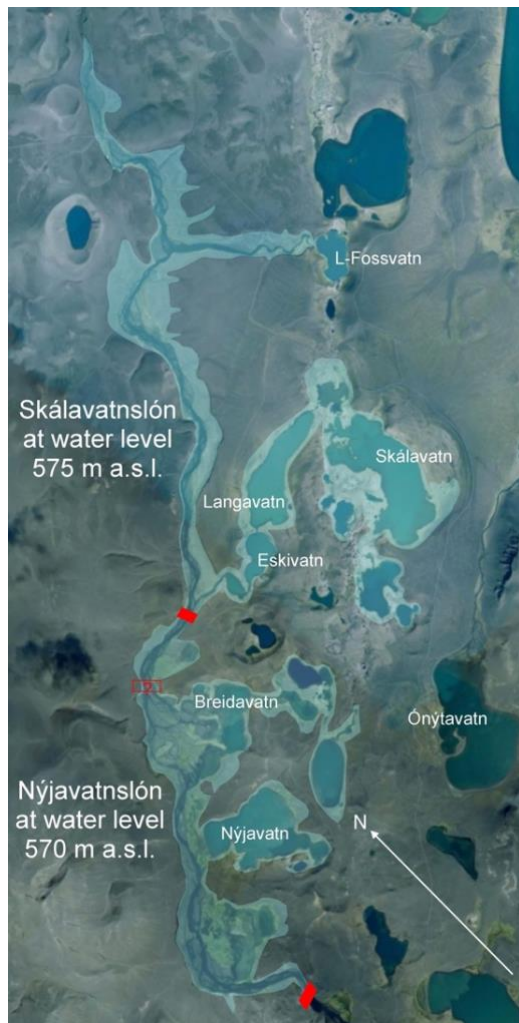
Figure 6-4. Aerial photograph from MAP.IS Loftmyndir ehf. Transparent blue overlay indicates the potential temporary extent of Skálavatnslón and of Nýjavatnslón farther downstream, based on shorelines (see Figs. below) and the present topography and elevation.

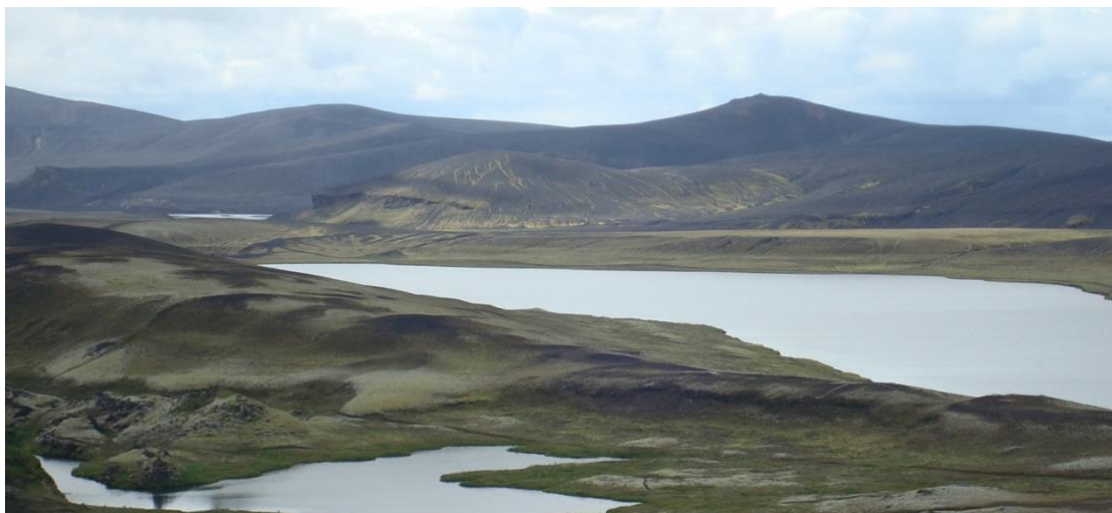
Figure 6-5. Photograph looking westwards across lake Skálavatn towards lake Langavatn. A distinct shoreline is seen (halfway up) in the crater rim that forms the far bank of Langavatn. A lava bench of former lava lake lies below the shoreline.

The temporary Skálavatnslón covered the present Skálavatn, Langavatn and several other lakes as well as parts of the rivers Vatnakvísl and Fossvatnakvísl. Around Skálavatn and Langavatn 2-3 shorelines can be discerned (Figs. 6-4 to 6-6) as well as “washed” horizons on the tephra flats around the rivers, here termed “bathtub marks” (Figs. 6-7 and 6-8).

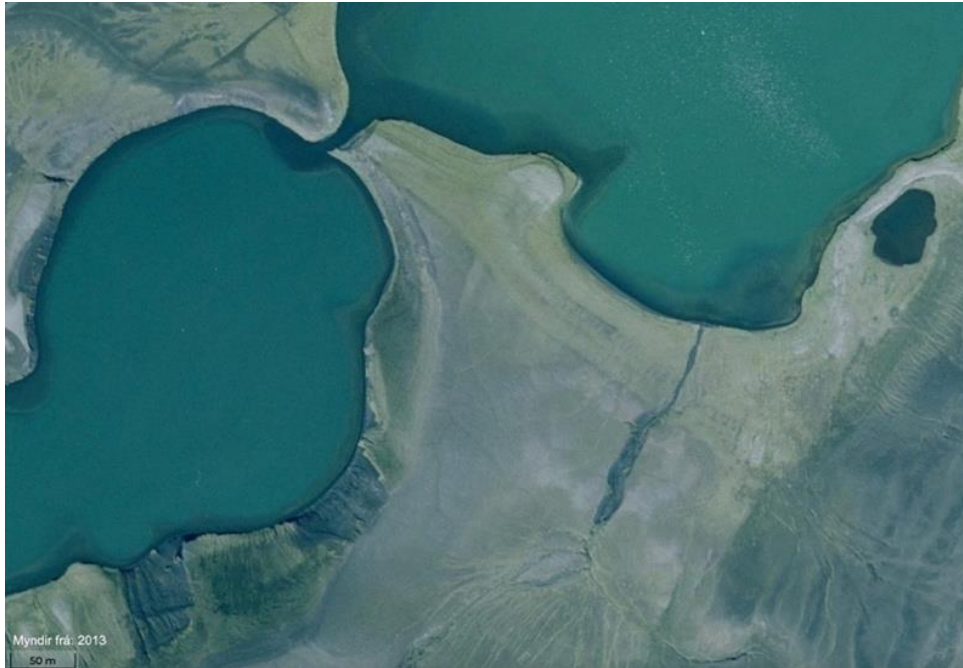
Figure 6-6. Aerial photograph from MAP.IS Loftmyndir ehf. showing the south end of lake Langavatn, the narrow outlet and part of adjacent lake Eskivatn (left). A well-developed shoreline is evident at the south end of Langavatn.

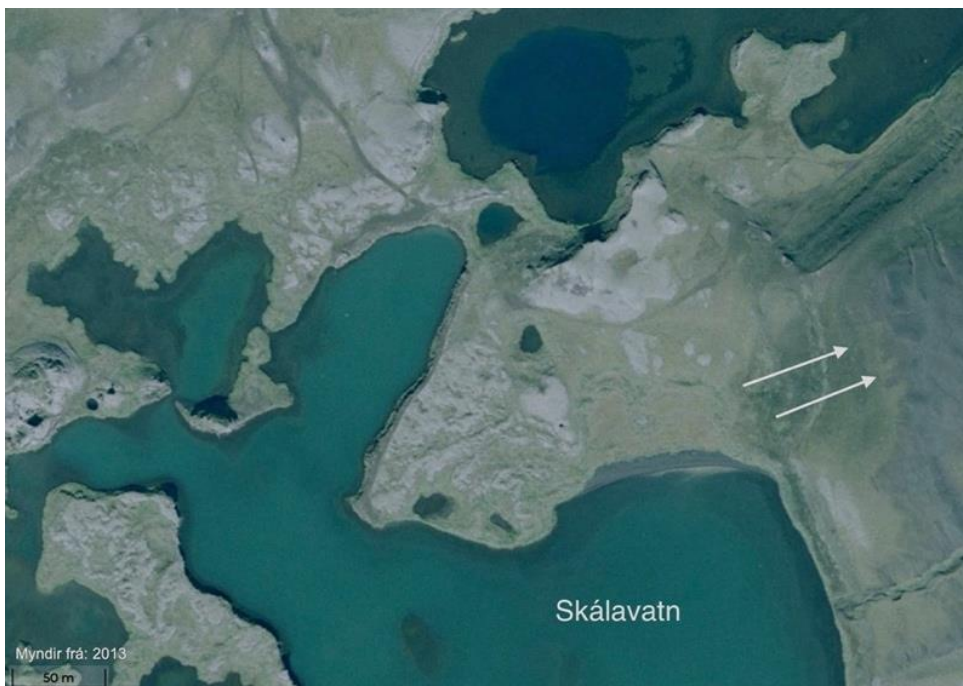
Figure 6-7. Aerial photograph from MAP.IS Loftmyndir ehf showing two shorelines dug into the tephra in a crater rim at the north end of Skálavatn (arrows). The distinct line or step below the shorelines is a lava bench formed by a former lava lake within the tephra ring.
