## **Tephra dammed lakes in the Veidivötn area, Iceland: 2000 years of lake evolution within a volcanic system.**

Guðrún Larsen  
Institute of Earth Sciences  
University of Iceland

2023

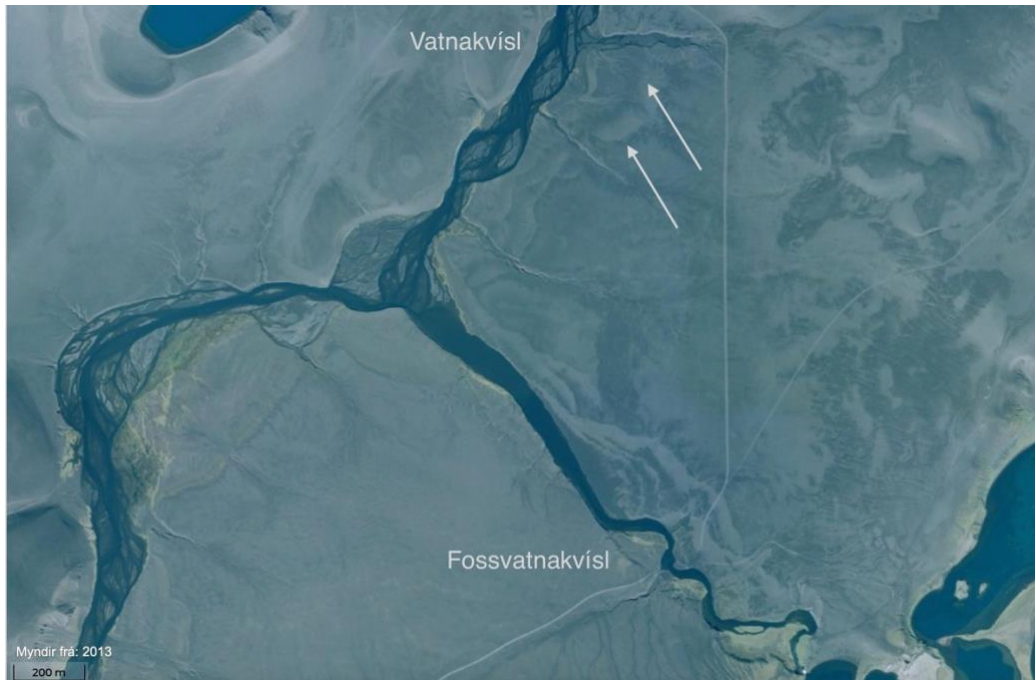
Figure 6-8. Aerial photograph from MAP.IS Loftmyndir ehf, showing the confluence of Vatnakvísl and Fossvatnakvísl rivers (overview on Figure 6-10). Arrows indicate “bathtub marks” on the tephra flats along Vatnakvísl. Note how the bathtub marks grade into eroded shorelines or steps along Fossvatnakvísl.

The temporary Skálavatnslón covered the present Skálavatn, Langavatn and several other lakes as well as parts of the rivers Vatnakvísl and Fossvatnakvísl. Around Skálavatn and Langavatn 2-3 shorelines can be discerned (Figs. 6-4 to 6-6) as well as “washed” horizons on the tephra flats around the rivers, here termed “bathtub marks” (Figs. 6-7 and 6-8).

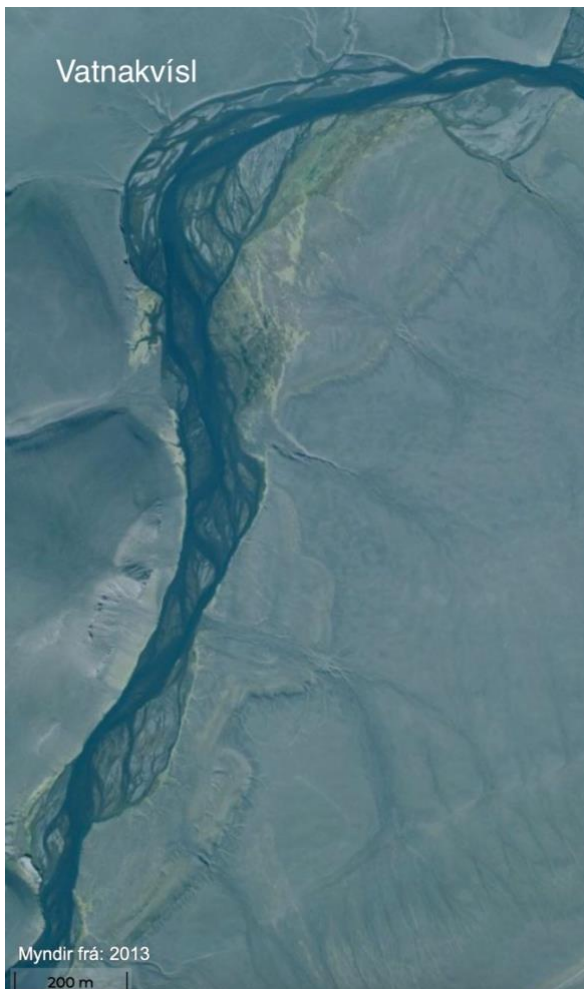
Figure 6-9. Aerial photograph from MAP.IS Loftmyndir ehf. Close-up of the bank of Vatnakvísl river, with 2-3 steps in the east bank, showing water level of lake Skálavatnslón during stepwise emptying.

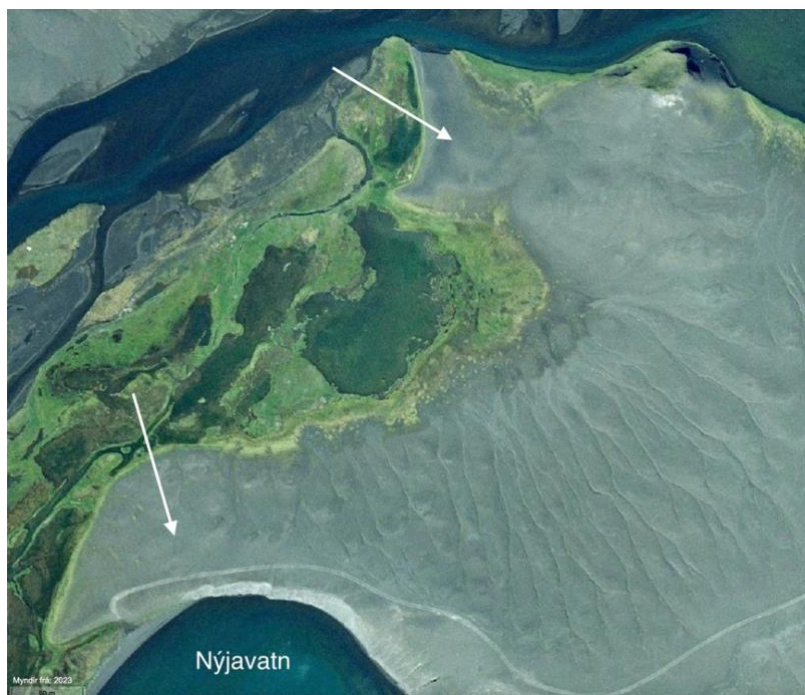
Figure 6-10. Aerial photograph from MAP.IS Loftmyndir ehf. The temporary Nýjavatnslón left indistinct watermarks such as washed surfaces (white arrows). Note the smoother „texture“ of the two low areas compared to the texture higher on the slope. Aerial photo from 2013.
